Sand-capping stabilizes muddy sediment and improves benthic light conditions in eutrophic estuaries

Laboratory verification and the potential for recovery of eelgrass (Zostera marina)

Published in: Journal of Sea Research

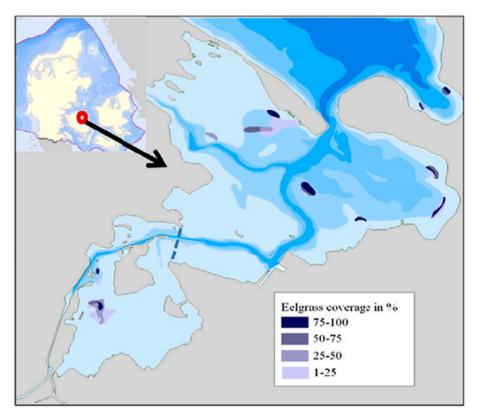
Fig. 1. Map of Odense Fjord with the current eelgrass distribution indicated. The dashed line indicates the boundary between the inner and outer part of the system.

Odense Fjord (2.2~m average water depth and 0.3~m tidal amplitude) is divided into a $17~km^2$ inner and a $46~km^2$ outer part (Fig. 1). The shallow inner fjord (0.8~m average depth) is impacted by freshwater discharge from Odense River, while the outer fjord has a more variable

bathymetry (2.7 m average depth) and connects to the open sea (Kattegat) through a narrow opening in the northeast (Fig. 1). Depending on freshwater input and exchange with Kattegat, the salinity varies from 5 to 17 and 15 to 25 in the inner and outer fjord, respectively (Petersen et al., 2009). Odense Fjord has a relatively large catchment area (1046 km²) providing a substantial nutrient loading primarily due to agricultural runoff. Prior to 1990 the fjord received 2500 t N vr⁻¹ and 300 t P vr⁻¹, but after the implementation of several water action plans the nutrient loading has been reduced to the present levels of 1500-2000 t N yr $^{-1}$ and 50–70 t P yr $^{-1}$ (Petersen et al., 2009). This has improved the water quality, diminished growth of opportunistic macroalgae and increased coverage of widgeon grass (Ruppia maritima) in the shallow inner fjord. Nevertheless, Odense Fjord does still not comply with the European Water Framework Directive (EU WFD) requirements with respect to eelgrass (Z. marina) depth limit, phytoplankton chlorophyll a and nutrient concentrations (Petersen et al., 2009). In the reference condition (i.e. around year 1900; Ostenfeld, 1908), eelgrass had a depth limit of about 5.5 m and covered substantial areas of Odense Fjord (\sim 50–60%), while the depth limit today is below 2.5 m and only 2% of the estuary is covered by eelgrass patches (Timmermann et al., 2020). The EU WFD Water Management Plan targets a depth distribution for eelgrass of about 4.1 m in Odense Fjord, corresponding to 75% of the eelgrass depth limit in the reference state. Eelgrass has not shown signs of recovery in Odense Fjord - in neither shallow nor deeper areas (unpublished data from the National Monitoring Program) - indicating that light availability is one of the stressors affecting eelgrass distribution in the system (Kuusemäe et al., 2016; Flindt et al., 2016). The combined action by multiple stress factors maintains the estuary in poor to moderate ecological condition. Particularly the organic-rich conditions in large parts of the fjord prevent proper consolidation of the surface sediments that are prone to frequent resuspension events (Canal-Vergés et al., 2010; Kuusemäe et al., 2016).

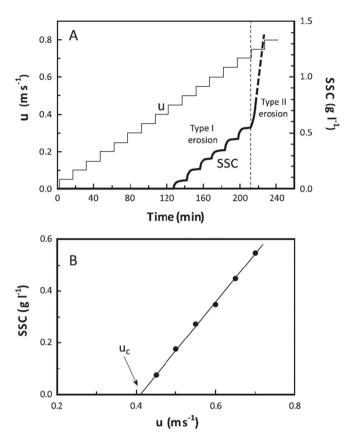
Fig. 2. (A) The outcome of a typical erosion cycle with 0.05 m s^{-1} increments in current velocity. The thin line represents free-stream current velocity (u). The thick line represents the stepwise increase in suspended sediment concentration (SSC) within the Type I erosion zone and the more erratic and unpredictable pattern (dashed part) within the Type II erosion zone. The vertical dashed line separates Type I and Type II erosion. (B) Regression used to estimate the erosion threshold. The critical current velocity (u_c) was estimated as the zero SSC intercept from a regression of measured SSC against u.

Tests of erosion threshold for each muddy sediment class was first performed in three flumes (n = 3) with a mud layer of 10 cm (18 flumes in total) and subsequently the erosion trials were repeated with a sandcap layer of about 10 cm on top of the mud. The sediment consolidated for 24 h under experimental conditions in estuarine water (temperature: 14 °C; salinity: 18) before erosion trials, while the flume was maintained under a constant free-stream current velocity (u) well below the critical erosion threshold (about 0.02 m s⁻¹). The flume water was aerated to avoid oxygen depletion, but gently enough to prevent sediment disturbance. During erosion trials, the sediment was subjected to increasing current velocities in incremental steps of 5 cm s⁻¹ with 15 min duration, i.e. the time required to reach a steady state concentration of suspended solids (Fig. 2). Increments continued until a suspended solid concentration (SSC) of 0.5–1.0 g L⁻¹ was achieved, or the turbidity signal was saturated. The critical erosion threshold (u_c) was defined as the current velocity where a significant increase in turbidity appeared during the stepwise velocity increments. Water samples were collected at every velocity step (after 15 min) for determination of SSC (g L⁻¹). Sampled water was replaced continuously with ambient estuarine water to avoid water level changes in the flumes. SSC was determined as the dry material recovered after filtering through pre-weighted GF/C filters and related to the corresponding turbidity (NTU) output to establish a calibration curve. Erosion rate (E, g m⁻² min⁻¹) was calculated from the point at which the erosion threshold was reached for each velocity increment. Thus $E = V^*\Delta SSC/A/\Delta t$, where V is water volume in the flume (L), ΔSSC is the increase in SSC (g L^{-1}) during the time step Δt (min) and A is flume area (m^2).

Samples taken from the flume trials at the end of each velocity increment were used to determine the relationship between suspended solids (SSC), free stream velocity and Lambert-Beer's coefficient (k). For this purpose, the light attenuation coefficient of suspended mud (LOI = 8.0%) and sand (LOI = 0.4%) was measured by suspending each sediment type (n=3) at stepwise increasing concentrations into a transparent acrylic column ($\phi=30$ cm, h=200 cm) prefilled with estuarine water (temperature: 14 °C; salinity: 18). A constant concentration of SSC per step was insured by two pumps with inlets at the bottom and outlets at surface of the water column. The light intensity was monitored using a LI-COR Data Logger (LI-1000) placed 50 cm above the bottom. Light attenuation through the water column was calculated using Lambert-Beer's equation: $L_d=L_0$ * $e^{(-k_*d)}$, where L_d is the light intensity at depth

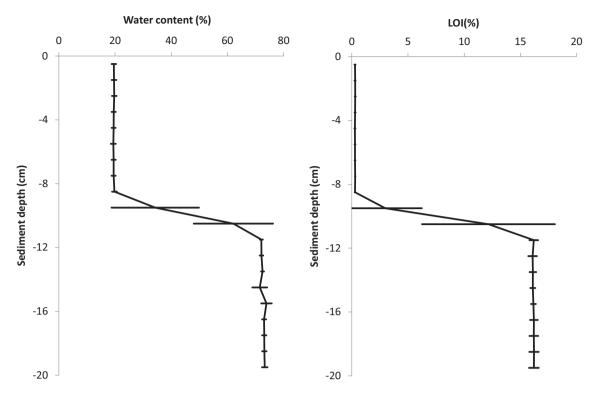
Fig. 3. Final vertical profiles of water content (left) and LOI (loss on ignition) (right) after sand-capping of 16.2% LOI muddy sediment. The horizontal bars represent the standard deviations at each depth (n = 5). Results of the other mud classes are summarized in Table 1.

The most pronounced impact of sand-capping was expected for mud classes with the smallest grain size. Thus, initial WC and LOI of the richest mud were 4 and 50 times, respectively, higher than those of the applied sand (Fig. 3). These differences were still apparent at the end of the experiment where sand and mud layers remained clearly separated with a narrow vertical mixing zone of 1–2 cm. However, the shape of mixing zones varied among replicates and extended from 9 to 11 cm depth as evident from the high standard deviations. Nevertheless, preservation of the initial characteristics of both sand and mud together with the maintenance of a rather narrow mixing zone after sand-capping, demonstrates that the heavy sand did not sink into the lighter muddy sediment in any of the tested mud classes (Table 1; Fig. 3).

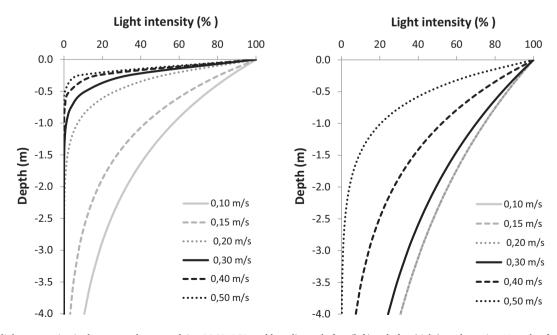
Fig. 6. Vertical light attenuation in the water column overlying 16.2% LOI muddy sediment before (left) and after (right) sand-capping. Note that for sand, 0.10, 0.15 and 0.20 m s⁻¹ lines are on top of each other.

The experimentally derived light attenuation coefficient (k) of 0.092 $\pm~0.039~m^{-1}$ for the 16.2% LOI mud and 0.057 $\pm~0.024~m^{-1}$ for sand provided distinctly different light attenuations in the water column as a

function of current velocity in the flume (Fig. 6). Light penetrated much deeper in water overlying sand than mud at all current velocities.
